LEARNING FROM INCIDENTS AWARENESS ALERT

PTP-IG-AW-201801

P&T – Prelude FLNG

FAILURE OF EXO CHAIN HOIST

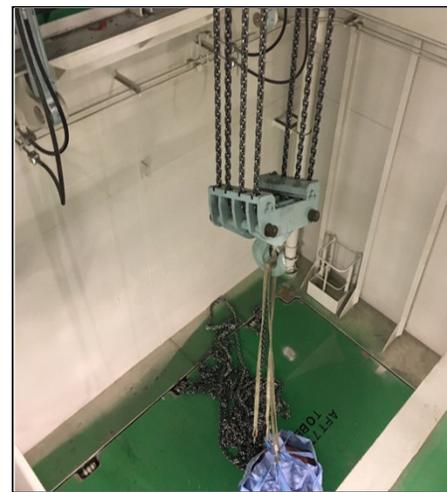
A 35 tonne Safe Working Load (SWL) electrically driven chain hoist was being used to lift ~200kg garbage bags from the floor in the aft machinery space to the 2nd deck, a distance of approximately 35m. The chain jammed in the hoist mechanism, ultimately leading to shearing of the pins connecting the hoist gearbox output shaft to the chain drive, allowing the chain drive to free wheel and 250kg of chain to run out, resulting in the chain falling to the floor. The area was a barricaded loading zone. No one was hurt.

- Chain jammed at the hoist chain guide inlet, due to inadequate chain bucket design. Functional requirements specified for this hoist (Ultra Low Head Room, 35t SWL and 35m lift) had led to the possibility of a 'full' chain bucket.
- Bolts connecting the hoist synchronisation chain to the drive sprocket failed, allowing loss of tension on the synchronisation chain.
- The plunger-head type limit switch, designed to stop the hoist on loss of tension in the synchronisation chain, mechanically failed to operate.
- Upon inspection, corrosion was found inside the limit switch, stopping the limit switch from extending when required.
- With the synchronisation chain inoperable, hoisting continued and the chain bundled inside the hoist mechanism, locking the gearbox drive from further movement.

- Upon inspection, the motor overload protection (MOP) settings, designed to protect the motor in the event of overload when hoisting, were not set correctly, leading to overtorque of the drive and gearbox pin failure.

- Ultra Low Headroom Hoists are not recommended for mechanical handling requirements where both high load and high lift height are a functional requirement;
- Assets to verify existence of Ultra Low Headroom Hoists in their facilities (those with synchronisation chain in the mechanism); for these hoists, verify with OEM the need to update inspection/maintenance regimes to confirm robustness of limit switches on these synchronisation chains.
